Debris/Ice/TPS Assessment and Integrated Photographic Analysis of Shuttle Mission STS-70

Gregory N. Katnik, Barry C. Bowen, J. Bradley Davis

13 July 1995

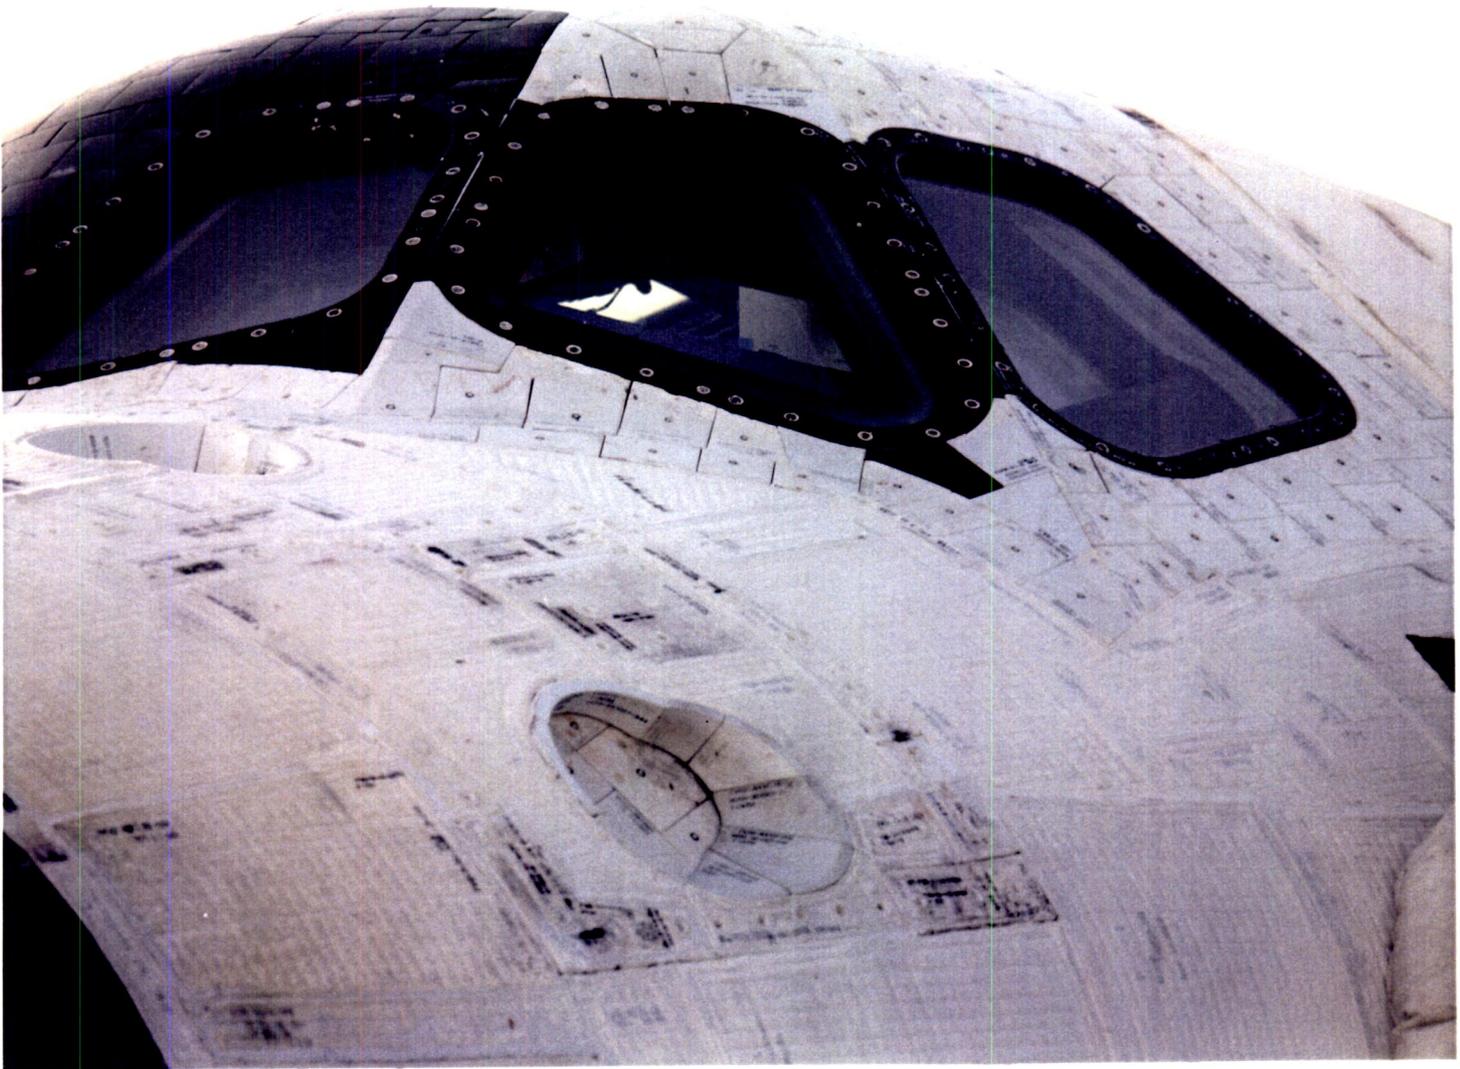
Photo 29 : Orbiter Windows

Orbiter windows #3 and #4 exhibited moderate hazing and streaking.
A light haze was present on the other windows.

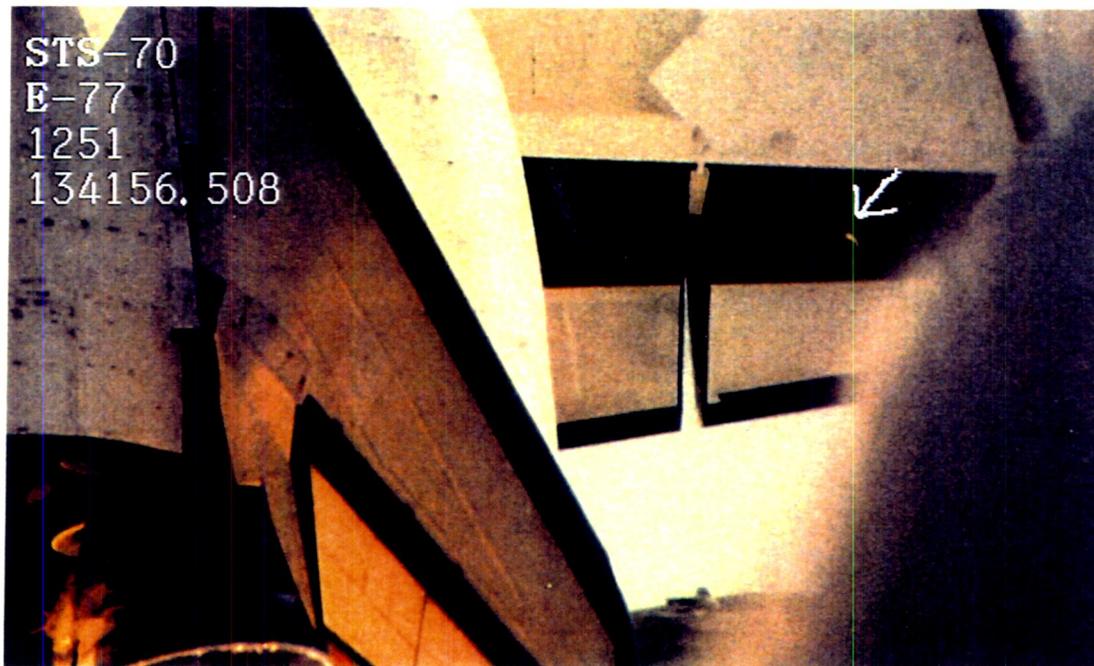
Figure 2.1.3.1 Debris Seen Near the Orbiter Right Wing Tip

A single dark colored piece of debris was seen near the Orbiter right wing tip moving in a westerly direction at liftoff. This debris fell aft into the exhaust cloud and was not seen to contact the launch vehicle (Figure 2.1.3.1). No follow-up action was requested.

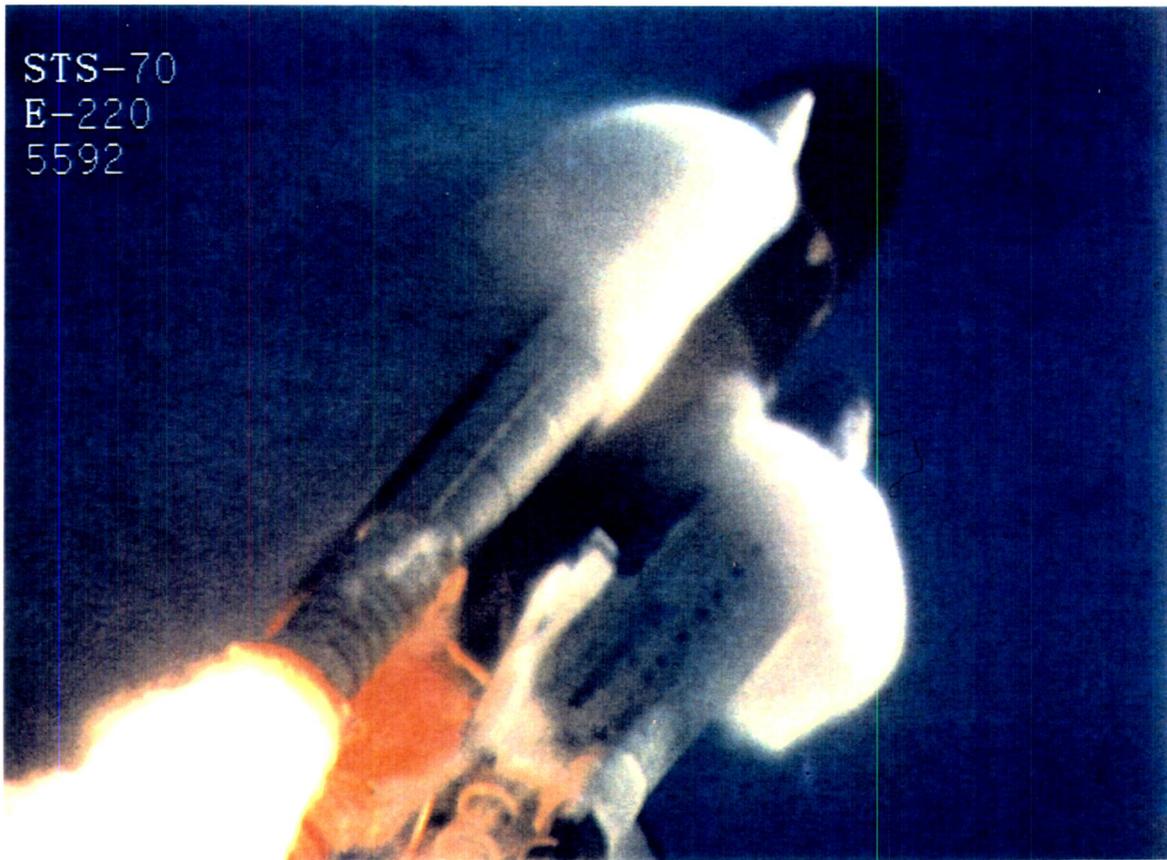
Figure 2.3.4 Condensation Seen Around Shuttle Launch Vehicle

Condensation was seen around the Shuttle Launch Vehicle between 44 and 57 seconds MET.

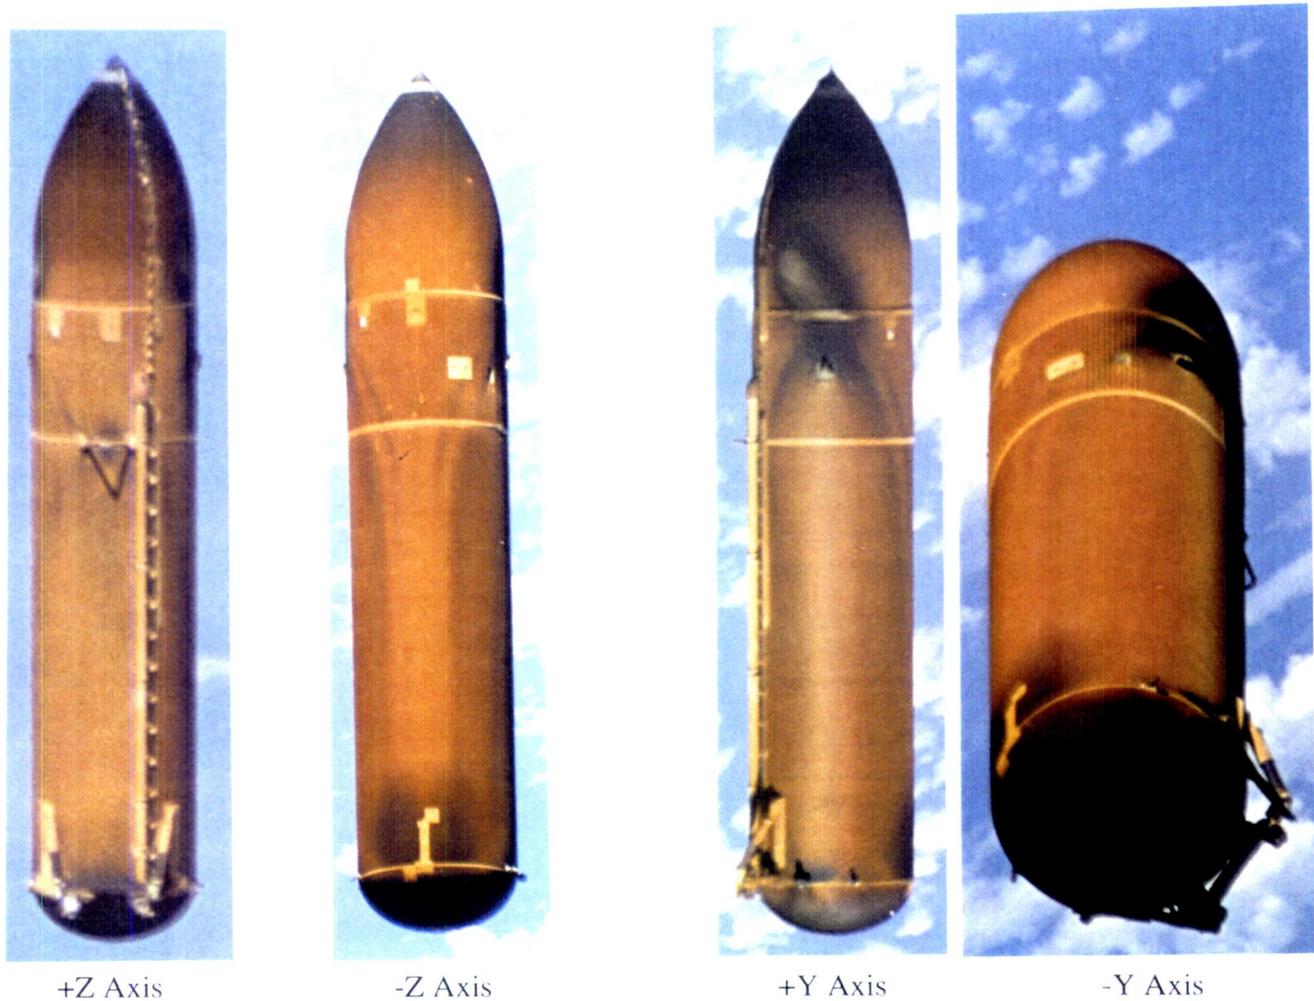
Figure 2.4.1 Handheld Photography of the External Tank

All aspects of the external tank (ET) were imaged (Figure 2.4.1). The external tank appeared to be in excellent condition. No anomalies were noted. The normal aeroheating marks and Booster Separation Motor burn scars are visible. Other marks visible on the external tank TPS were verified by KSC to be the repairs made prior to launch (woodpecker damage). These repairs appeared to be intact.

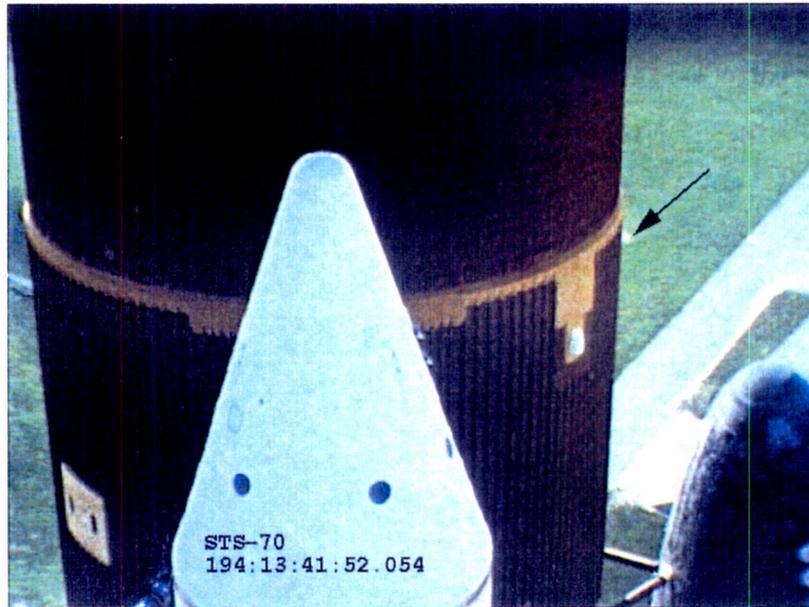
Figure 1 White vapors from ET aero vent

White vapors were observed venting from the ET intertank aero vent (+Z) during SSME start and liftoff. Five pulses of vapors were observed during this time. Figure one is a film frame from camera E-34 showing one of the pulses. This type of venting was last observed on STS-51.

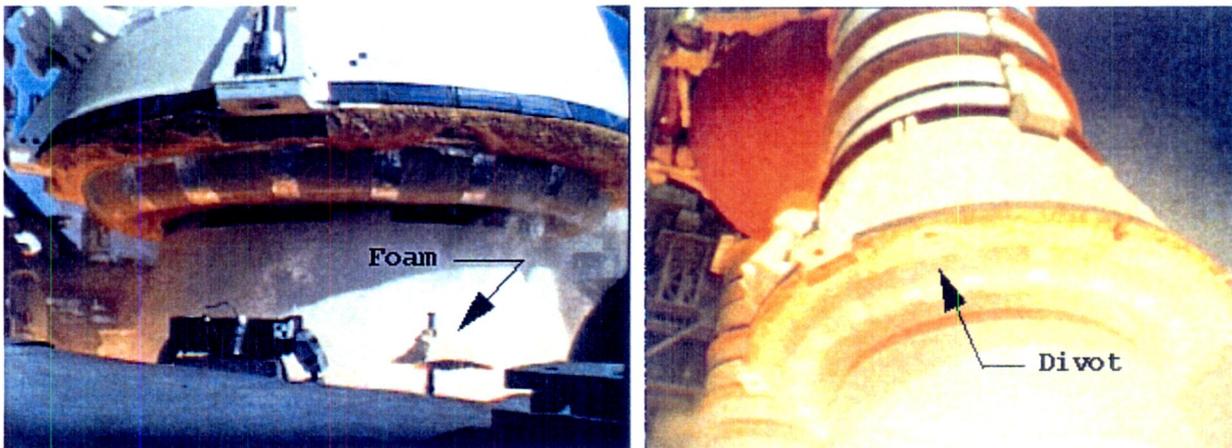
Figure 2 Instafoam on purge line and resulting divot

A large piece of instafoam remained attached to the right SRB aft skirt purge line at liftoff. Figure two shows this piece and the resulting divot at the base of the aft skirt instafoam. This piece was subsequently broken into several small pieces by the plume.

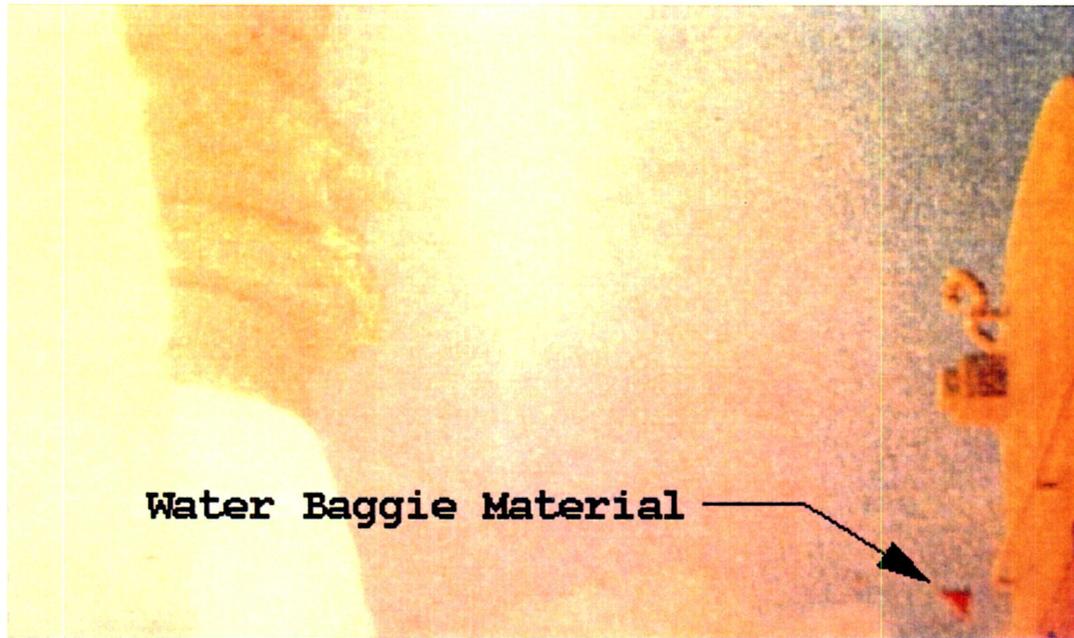
Figure 3 Water baggie material

Two pieces of water baggie material were observed rising from the SRB flame bucket and striking the LO2 TSM and falling back into the flame bucket at liftoff. Figure three shows this event as recorded by camera E-34.

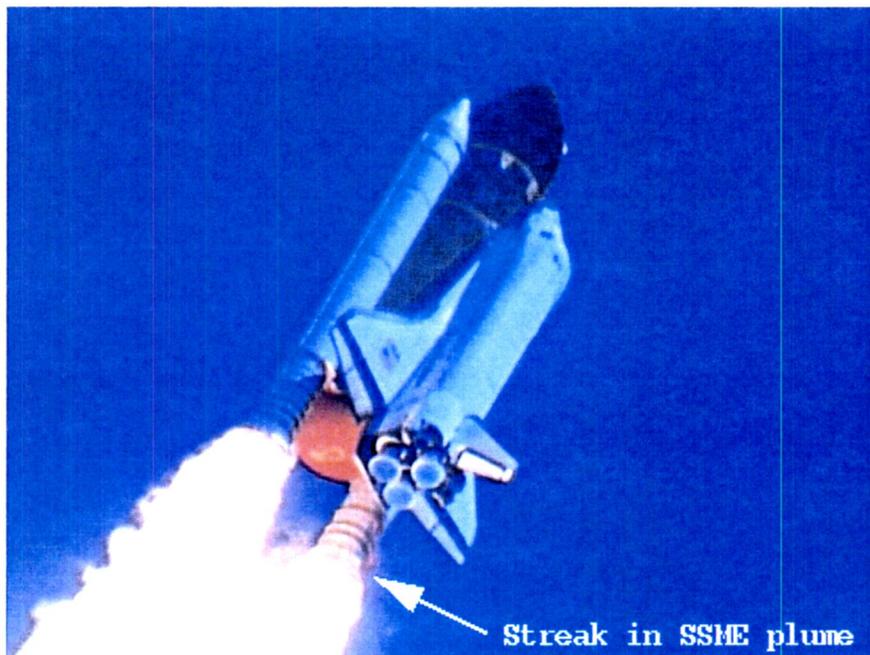
Figure 4 Debris induced streak in SSME plume

A debris induced streak in the SSME plume was observed on film from camera E-222 during ascent and is shown in Figure four. No time information is available.

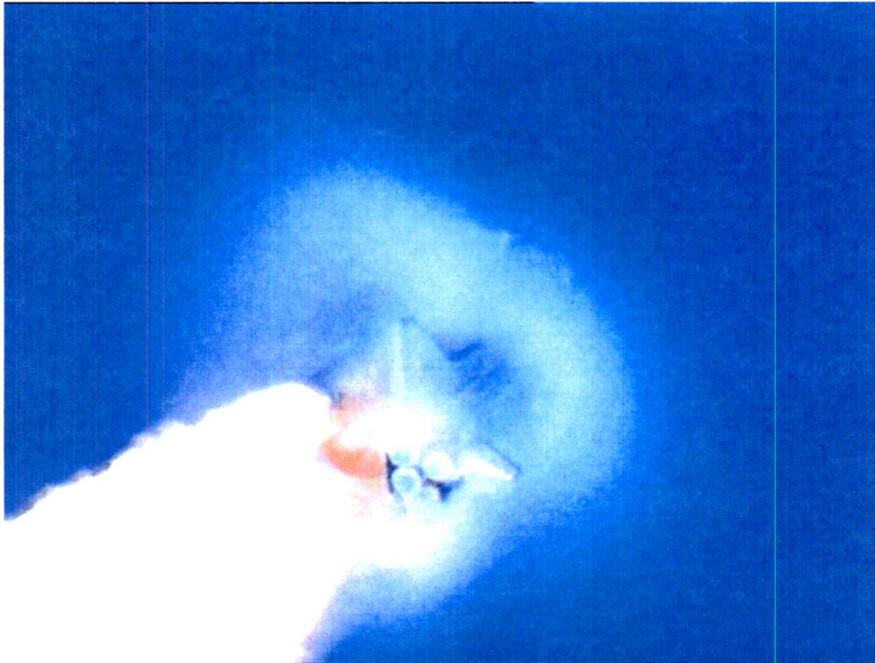
Figure 5 Condensation collar around vehicle

A pronounced condensation collar was visible around the vehicle during ascent between 44 and 57 seconds MET. Figure five shows this event from camera E-222. This type of event is attributed to unique atmospheric conditions.

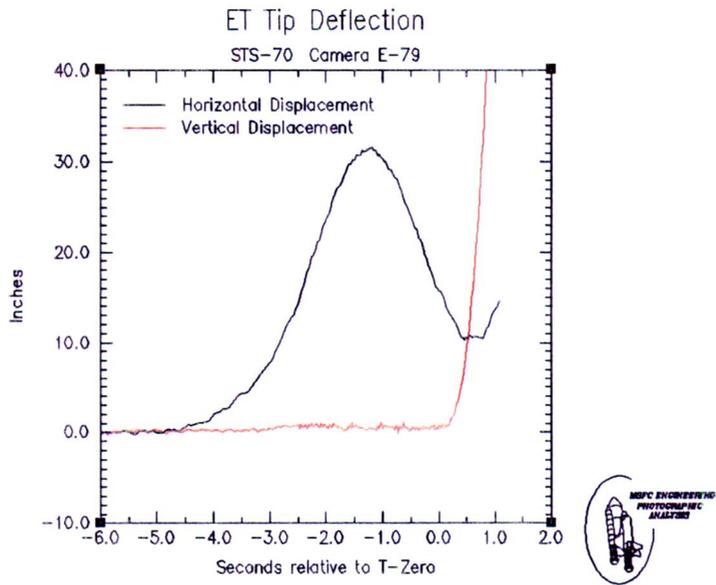
Figure 6 ET tip deflection

Maximum ET tip deflection for this mission was measured at 31.5 inches. Figure six is a data plot showing the measured motion of the ET tip in both the horizontal and vertical directions. A positive horizontal displacement represents motion in the -Z direction. These data were derived from film camera E-79.
